Precision Beyond Limits: Successful Instrument Retrieval from a Maxillary Bicuspid

Type of Publication: Original Research Paper

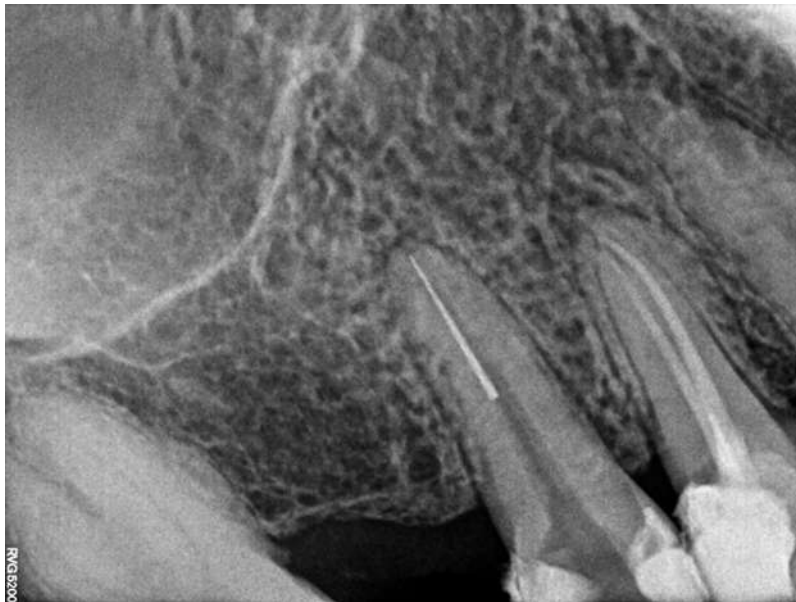
Fig.1- ProTaper file separated within the buccal canal at the apical third

After obtaining informed consent, rubber dam isolation was achieved to maintain an aseptic field. The old restoration was removed, and access cavity preparation was performed. The working length was determined using an electronic apex locator and confirmed radiographically. Root canal instrumentation was initiated with the ProTaper file system (Dentsply Sirona), progressing in sequence. However, during the cleaning and shaping phase, an S2 ProTaper file separated within the buccal canal at the apical third.(Fig 1)

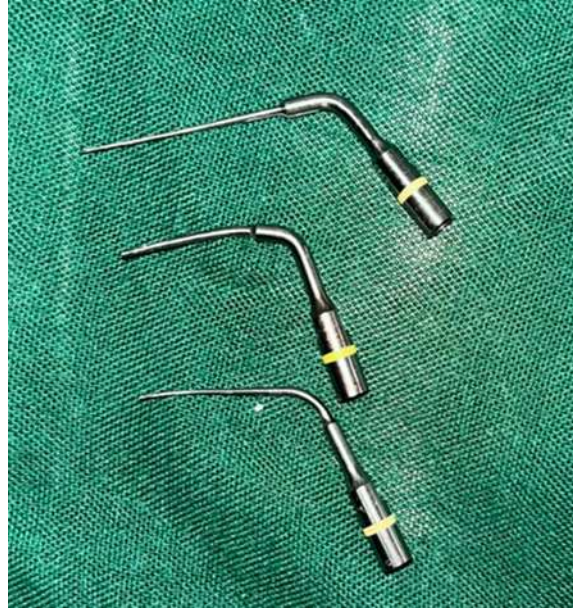
Fig 2- Satellac Ultrasonic tips

The decision was made to attempt retrieval of the separated instrument to improve the treatment outcome. Under magnification using a dental operating microscope (DOM) (Zeiss OPMI Pico) at 12.5 x magnification, the radicular access was carefully widened, and a staging platform was created using modified Gates-Glidden (GG) drills to provide better access to the coronal portion of the separated file. The Satelec P5 ultrasonic generator (Acteon, France) was utilized with ultrasonic tips ET18 and ET25 in sequential order to trephine dentin around the fragment with intermittent stroke in anticlockwise direction (Fig 2). The power setting was adjusted to level 4-6 for optimal efficiency without excessive heating.

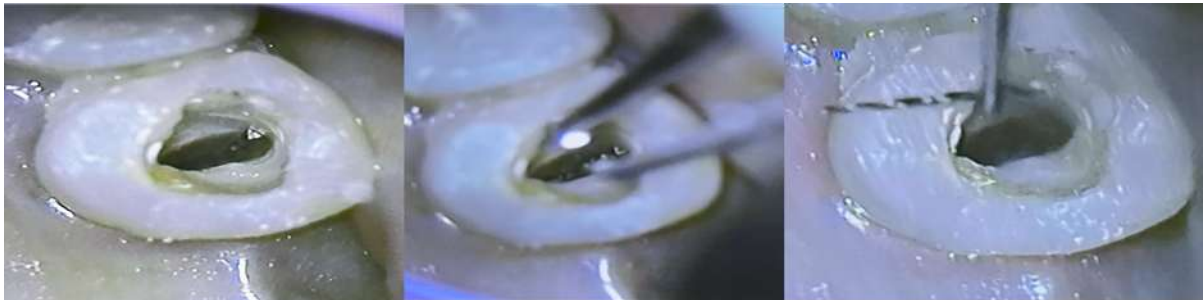
Fig 3 A- retrieval of separated instrument under microscope

Throughout the procedure, the canal was intermittently irrigated with 17% EDTA to remove debris and serve as a lubricant and coolant. After approximately 12 minutes of ultrasonic activation, the fragment loosened and was successfully removed

from the canal using a micro- tweeze (Hu Freidy)(Fig 3). A follow-up radiograph confirmed complete removal of the separated instrument. (Fig 4)

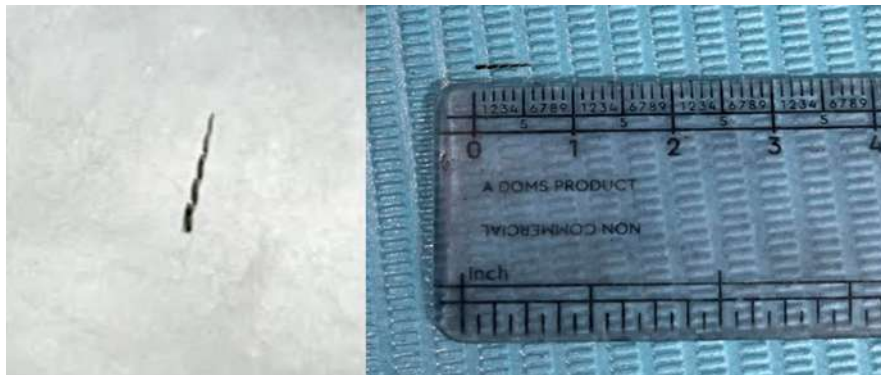
Fig 3 B- Separated instrument

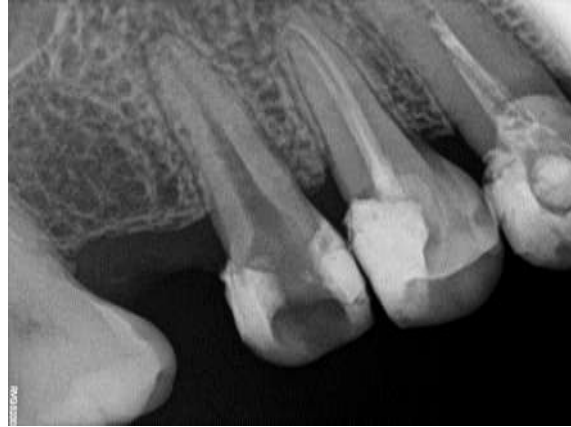
Fig 4 - Confirmation radiograph after instrument retrieval

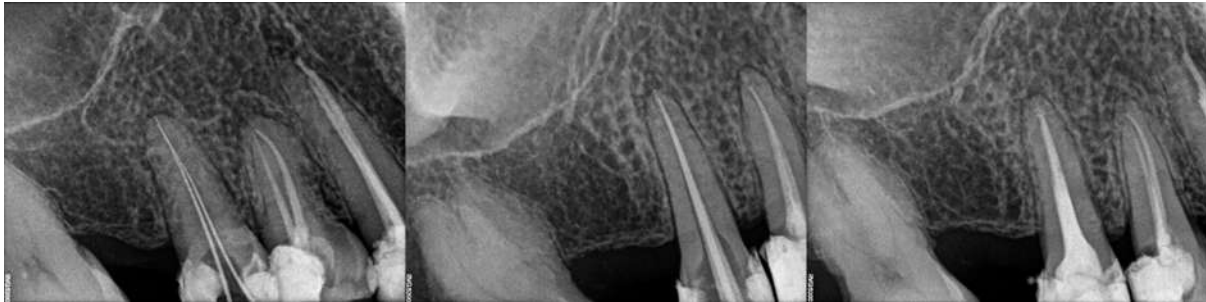
Fig 5- Completion of Root Canal treatment

With the instrument removed, the working length was re-established, and biomechanical preparation of the canal was completed with rotary ProTaper files to ensure thorough debridement. Following shaping and irrigation, the canal was dried, and obturation was performed using a Thermoplasticized GP obturation technique (Gutta flow, Dentsply) to ensure a well-adapted three-dimensional obturation without voids. The root canal space was sealed with gutta-percha in conjunction with a bio-ceramic sealer (BioActive RCS, Safe Endo to achieve a homogenous fill.(Fig 5)

A postoperative radiograph verified a satisfactory obturation with no voids or overextension. The tooth was subsequently restored with a resin composite (Tetric N Ceram Bulkfill Composite) to ensure optimal coronal seal and restoration of function. The patient was advised to return for follow-up visits at three and six months to monitor periapical healing. At the three-month follow-up, the patient remained asymptomatic, and radiographs showed favourable periapical healing.
