## Removal of Broken Helical Blade In Proximal Femur Fractures - A Novel Technique

Type of Publication: Original Research Paper

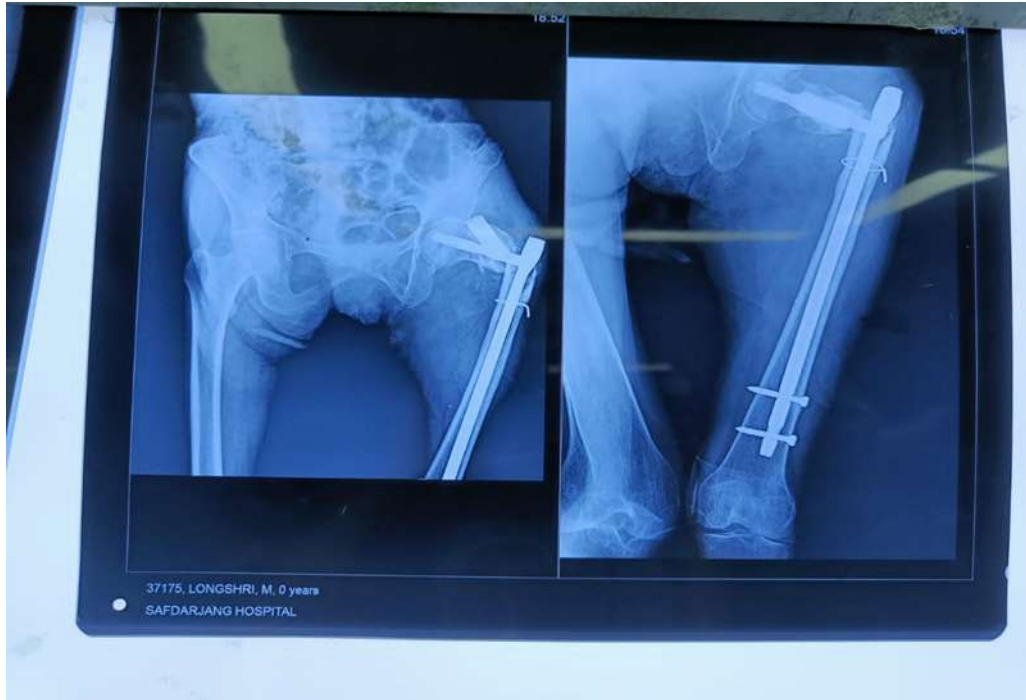
Lateral views were undertaken. The radiograph (Fig. 1) revealed fracture of intertrochanteric region of left proximal Femur and implant failure with broken pre-existing proximal femoral nail (PFN-A). Considering the previous history, patient was considered to be suffering from non-union of previous intertrochanteric fracture with implant failure due to subsequent trauma. Blood investigations revealed to be within normal limits with no sign of regional or systemic infection.

**Figure 1. Pre-operative Radiographs**

A plan for implant removal followed by revision of fixation along with bone grafting was made

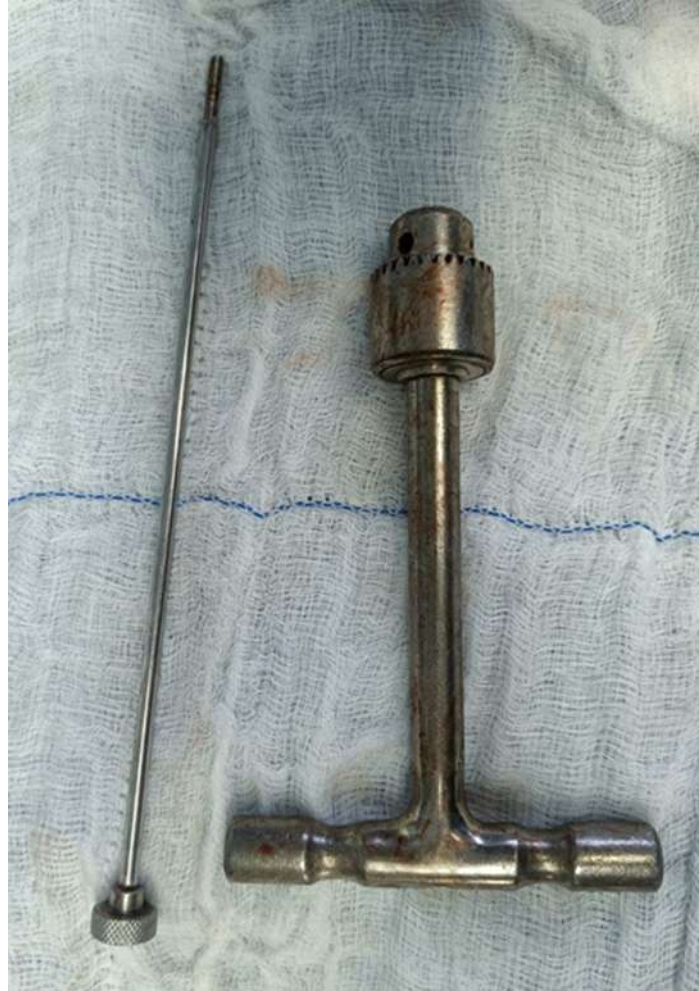
The original incision was utilised for the revision surgery; the incision was extended proximally and distally by 2 cm each. Surgical dissection was extended down to the bone after splitting the vastus lateralis muscle; Maintaining a stringently subperiosteal plane, the vastus intermedius and medialis origin were lifted subperiosteally and two curved Hohmann retractors were introduced to aid in retraction. Under the guidance of the image intensifier, first distal locking bolts were removed. (Fig. 2a and 2b) Outer broken part of the helical blade was removed manually from the lateral wall of the femoral cortex. Distal broken fragment of nail was removed subsequently from the fracture. Proximal broken fragment of nail was removed from the entry site of nail leaving distal broken fragment of helical blade. Attempt was made to remove the broken remnant of helical blade using PFN-A2 (indigenous manufactured) removal instruments and AO - nail removal instrumentation which was not successful. Depth of the broken remnant of helical blade obscured any attempts at application of pliers or bone nibbler to attempt extraction of the remnant. It was after these unsuccessful trials that an instrument was made using the long coupling screw for DHS screw removal (from DHS set kept as backup) and a T-handle (Fig. 3). Coupling screw was inserted into the broken fragment and rotated clockwise to jam into

**Figure 3. Custom instrument made for blade removal**

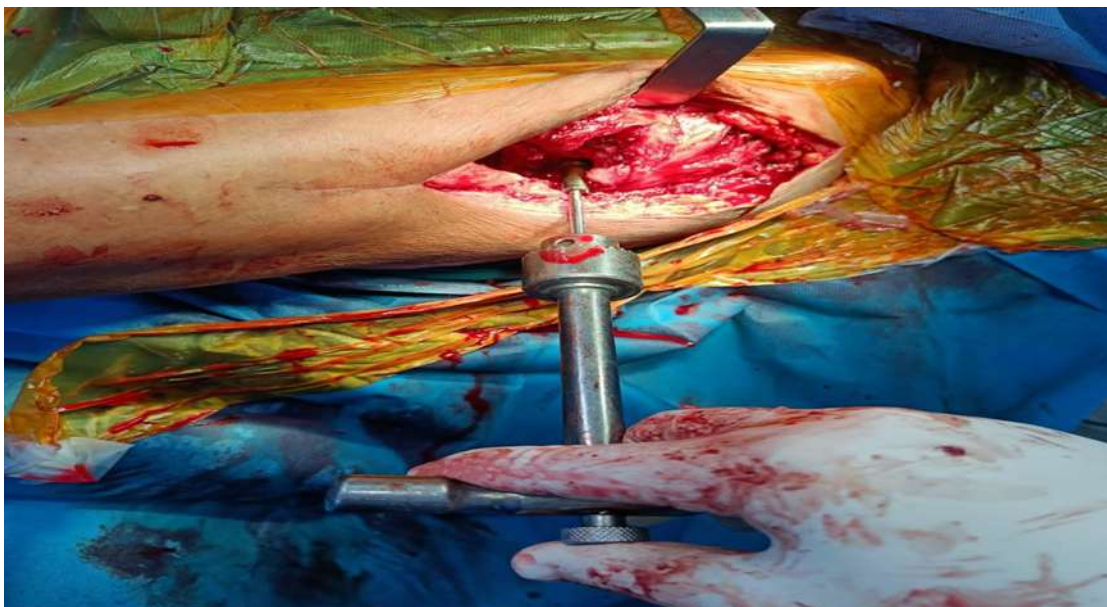
the broken fragment. Once the instrument found fixed under image intensifier, the T-handle was gently tapped outwards (Fig. 4). The screw fragment was retrieved from lateral window in femoral cortex for the Helical blade (Fig. 5a and 5b). Confirmation of removal of all fragments of broken helical blade was made on the side table before procedure was continued (Fig. 6). In view of fracture being in non-union, the fracture was fixed using a proximal femoral locking plate (PFLP) along with autologous and artificial bone grafting procedures (Fig. 7).

**Figure 4. Intra-operative image showing extraction of helical blade**

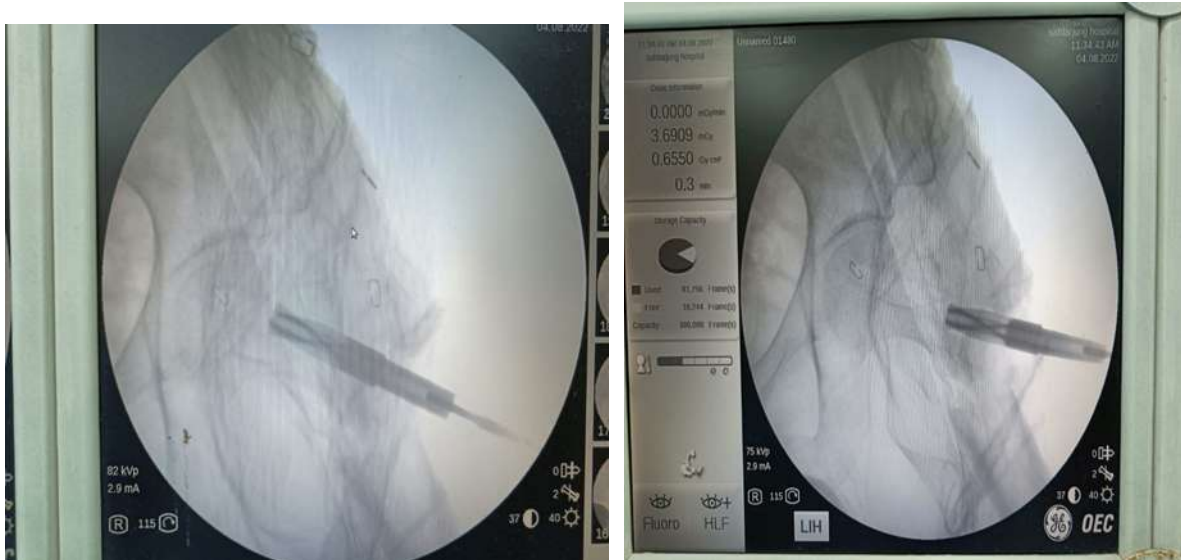
**Figure 5a and 5b. Image Intensifier images Intra-operative showing extraction of blade**

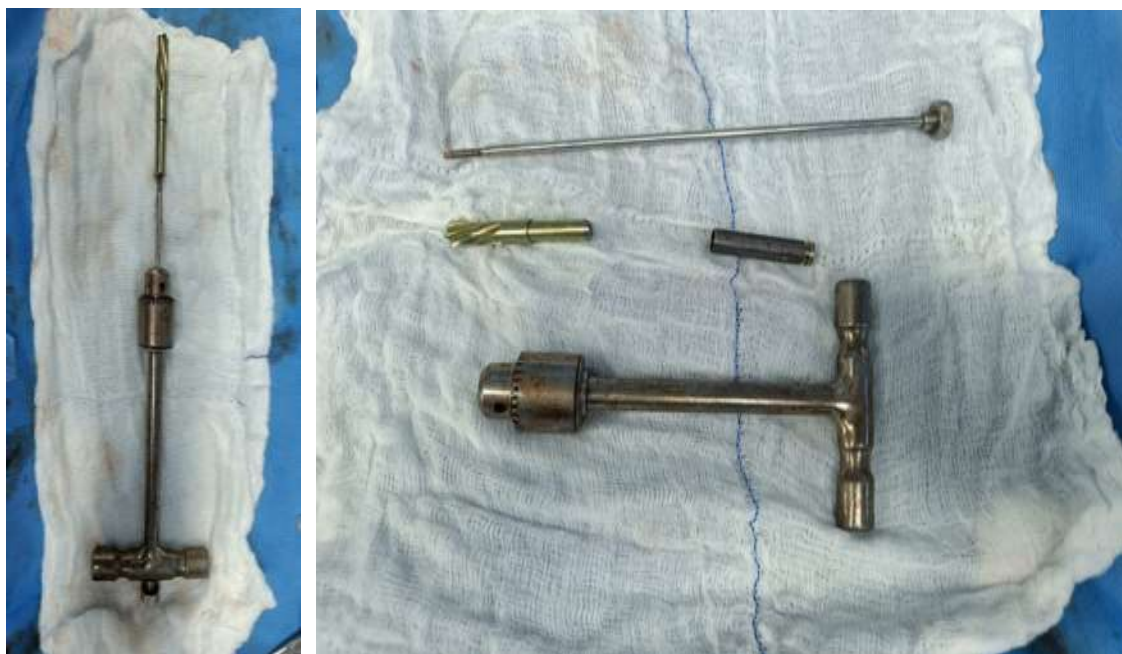
**Figure 6. Image showing extracted helical Blade**

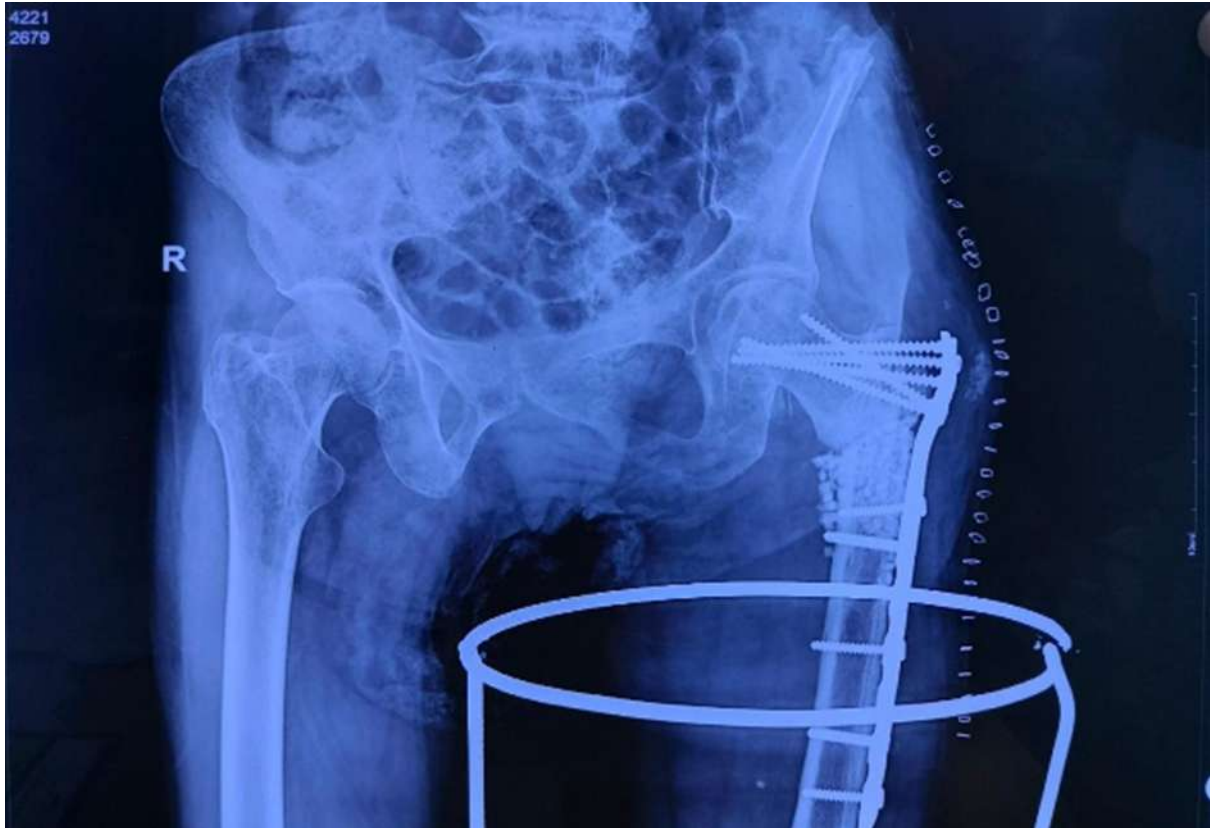
Figure 7. Post operative Image with fixation with Proximal Femoral Locking Plate
