Use Of Ribbond Fibre For Rehabilitation Of Endodontically Treated Teeth: A Case Report

Type of Publication: Case Report

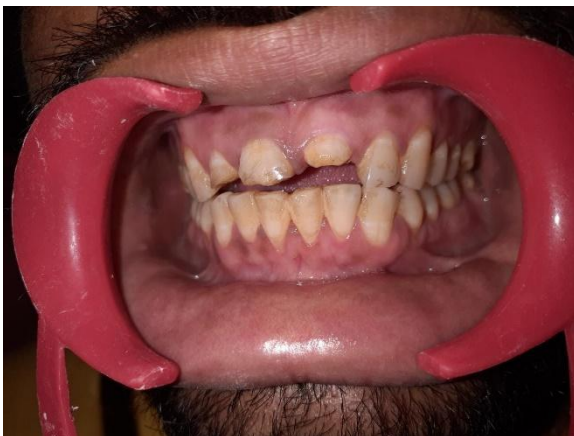
Fig 1: Preoperative photograph

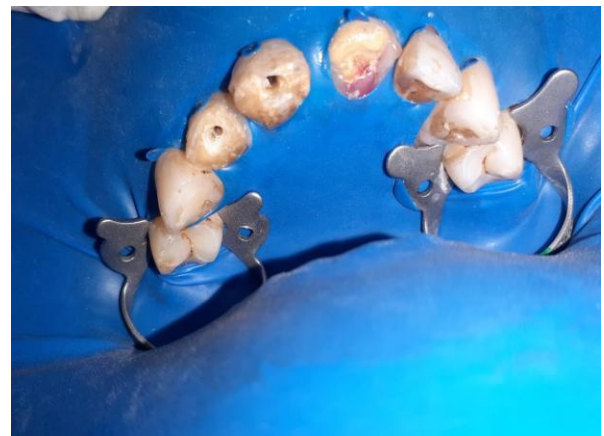
Fig 2: After endodontic treatment post space prepared

After local anesthesia with adrenaline 1:80000 and proper isolation with rubber dam access opening was done for the three teeth. It was then followed by biomechanical preparation and obturation with gutta percha. Temporary restoration was given and patient was recalled for post placement. During next appointment, treatment started after ensuring that there is no pain on endodontically treated teeth. The root canal treated teeth was prepared in the standard clinical manner with gates glidden drill. The canal was then prepared for bonding. A dual-polymerizing dentin-bonding agent will be applied to the canal and chamber surfaces and thinned with a brush. After the width of the reinforced polyethylene fibre is determined, the prepared dowel space is measured twice with a periodontal probe to determine the length of fibre needed. A highly filled, dual-polymerizing hybrid resin is then injected into the canal space. With the help of probe and tweezers ribbon was carried through the luting resin into the canal till the apical end of the canal. It was then cured with curing light. Composite was then applied to the protruding ends of ribbon into the shape of a core and cured. Suitable shades of Ivoclar Te Econom Plus was selected and built up. It was then cured, shaped and polished. Patient was instructed to come for further follow up.

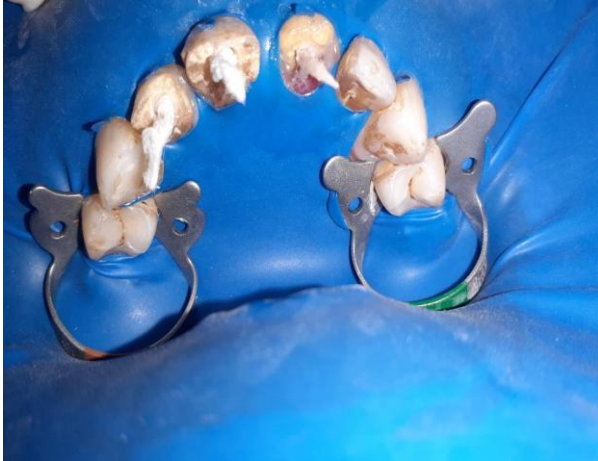
Fig 3: Ribbond placed as post inside the canal

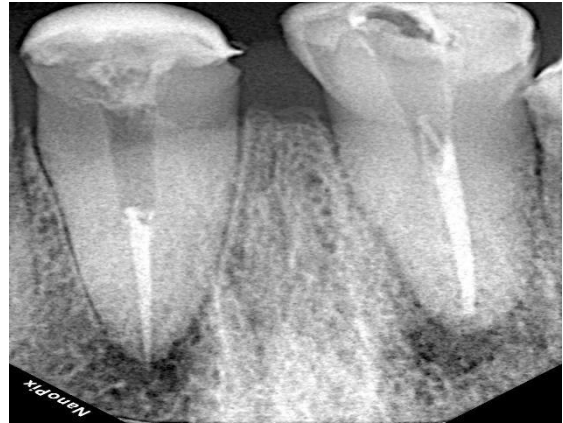
Fig 4: Radiographic image after post placement

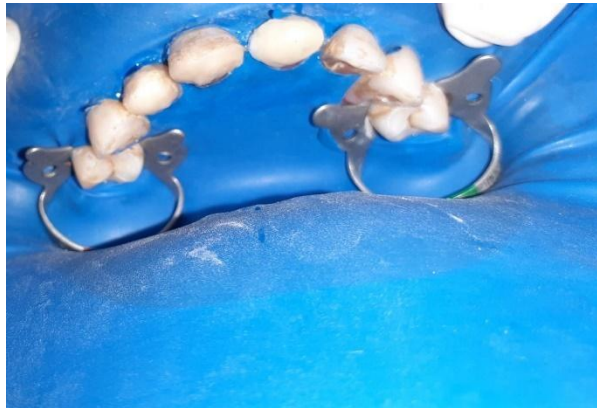
Fig 5: Core built up done with composite

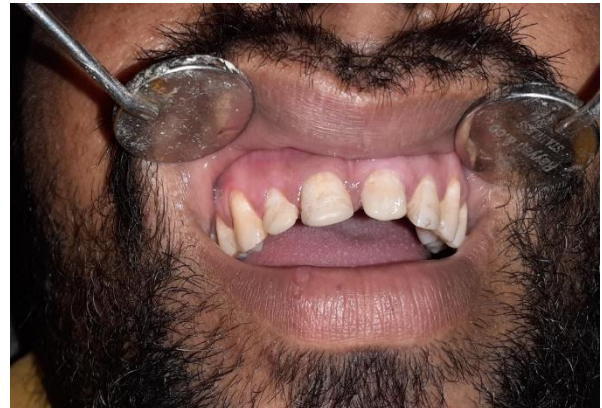
Fig 6 : After final shaping and polishing
