## Comprehensive Management of Iatrogenic Errors in a Mandibular Molar: A Case Report

Type of Publication: Case Report

Endodontic procedural errors such as ledge formation, perforations, and instrument separation complicate root canal therapy and may adversely affect long-term prognosis. This case report describes the comprehensive management of a mandibular molar that presented with a ledge in mesial canal, furcation perforation, and fractured instrument fragment in distal canal. Through systematic management, including ledge bypass, ultrasonic-assisted instrument retrieval, and mineral trioxide aggregate (MTA) repair of the perforation, full canal preparation and obturation were achieved. Follow-up radiographs demonstrated progressive periradicular healing, highlighting that modern endodontic techniques and biomaterials can salvage teeth with multiple complications.

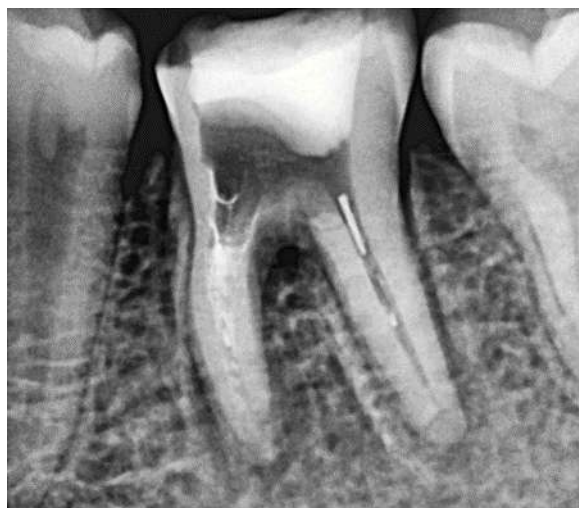
A 26-year-old patient reported with pain and discomfort in the mandibular left first molar. The tooth had been previously accessed and exhibited tenderness on percussion. Radiographic examination revealed incomplete endodontic treatment with a fractured instrument fragment in the distal root canal and a periapical radiolucency associated with both roots. A furcation perforation was also suspected radiographically. [Fig.1]

**Fig 1. Preoperative radiograph showing perforation in furcation area, instrument fragment in distal canal and radiolucency in periapical area and furcation**

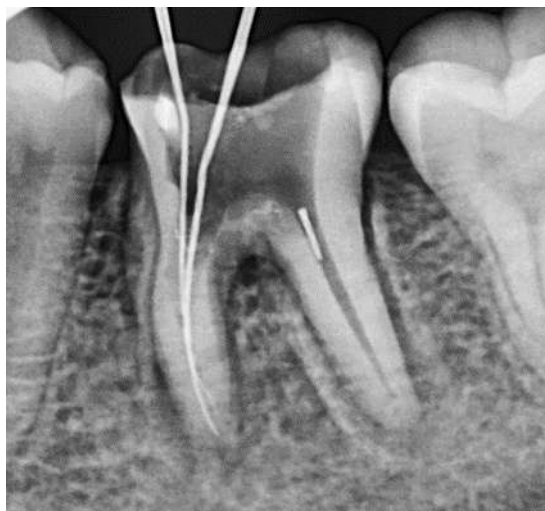
**Fig 2. Ledger is negotiated in mesiobuccal canal**

Rubber dam isolation was performed, and the access cavity was refined under magnification. The fractured instrument in the distal root and a canal ledge in the mesiobuccal canal were identified. A glide path was negotiated using pre-curved stainless steel hand files (#8, #10, #15) with watch-winding and balanced force techniques in the mesial canals. Patency to full working length was re-established in the mesial canals and the ledge was managed. [Fig.2] The fractured instrument was simultaneously bypassed with the help of stainless-steel hand files (#8, #10, #15) and working length was determined in the distal canal.

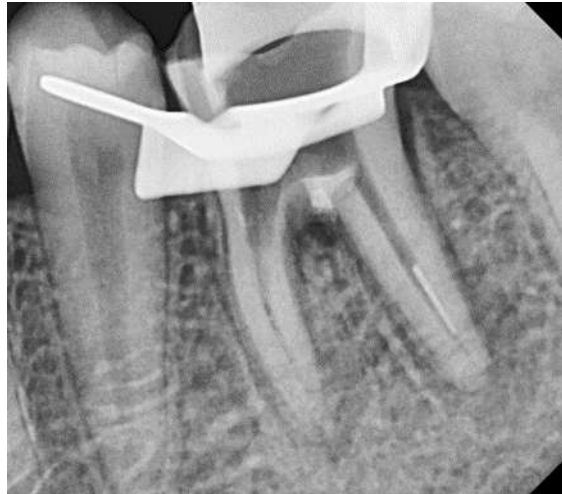
**Fig 3. Perforation repair done using MTA**

The bleeding control was then achieved from the perforation site in the furcation area. After blocking the orifices of the canals with the help of Teflon tape, perforation site was sealed with mineral trioxide aggregate (MTA). A moist cotton pellet was placed to facilitate MTA setting. [Fig.3]

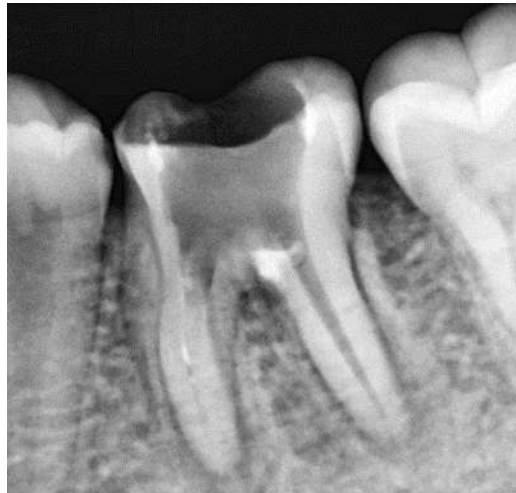
**Fig 4. Instrument retrieved from the distal canal**

The fractured instrument removal was attempted in the next appointment. The fragment was exposed using ultrasonic tips under the dental operating microscope. Controlled ultrasonic vibration successfully dislodged and copious saline irrigation following it, helped retrieve the fragment without excessive dentin removal. [Fig.4,5]

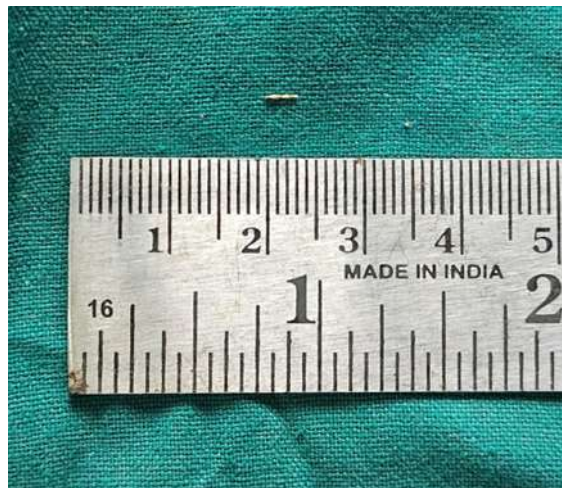
**Fig 5. Retrieved instrument**

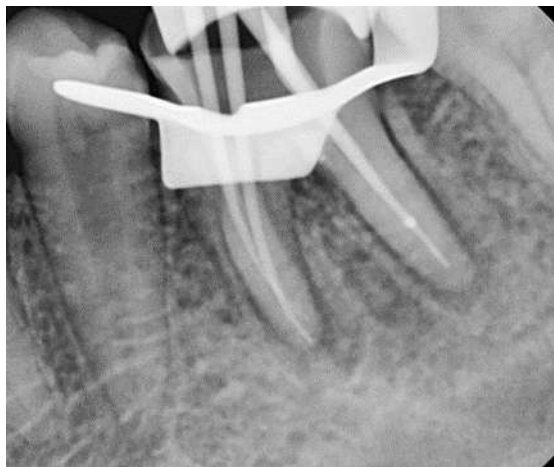
**Fig 6. Master cone radiograph**

The cleaning and shaping of the root canals were completed using rotary nickel-titanium instruments with copious irrigation of sodium hypochlorite and EDTA. Master cone radiograph was taken. [Fig.6]

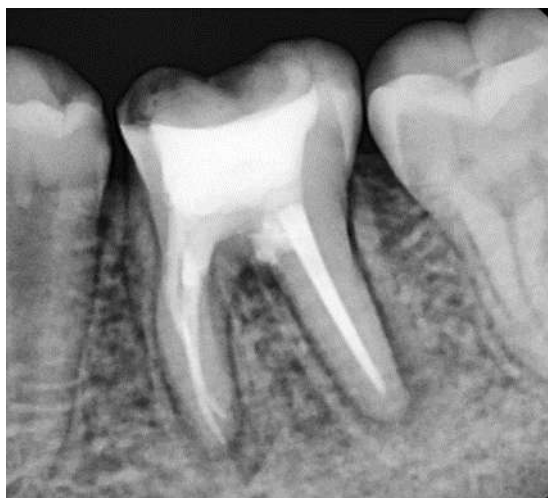
**Fig 7. Post obturation Radiograph**

Obturation was performed using the cold lateral compaction technique with a bioceramic sealer. The access cavity was restored with resin-modified glass ionomer followed by composite resin to ensure a durable coronal seal. [Fig.7]

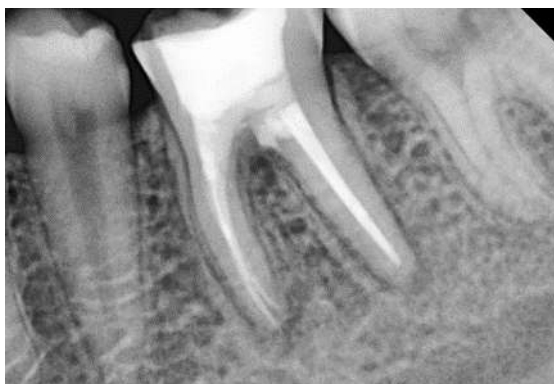
At three months, the patient was asymptomatic with no tenderness to percussion. Radiographs demonstrated initial signs of periradicular healing.

Progressive reduction in periapical radiolucency was evident, with bone trabeculation re-establishing in the furcation and periapical regions. [Fig.8]

**Fig 8. Follow-up radiograph of 3 months**
